Arizona Home Inspections, LLC

Home Inspection Report

835 N Rose Water Place
Tucson, AZ

PROPERTY INSPECTION

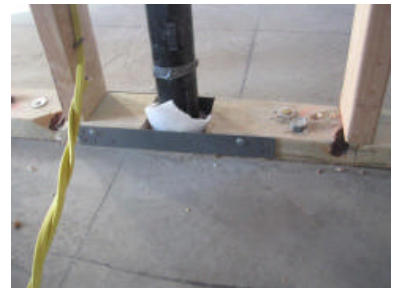
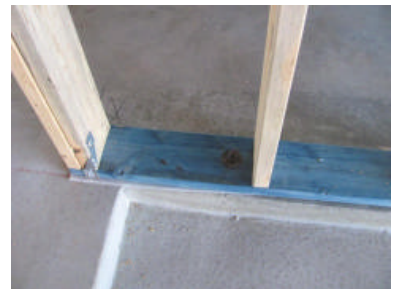
Correction Notice: Notches or bored holes were observed at the top or bottom plates which were 50 percent or greater of the top plate width without the required 1 1/2" galvanized metal tie fastener with 6-16d nails at each side of the notch or hole. The straps were missing the required nailing at several locations. **(R602.6.1)**

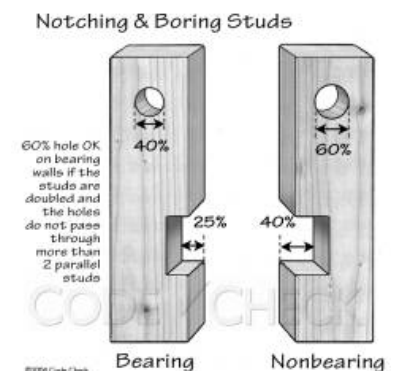
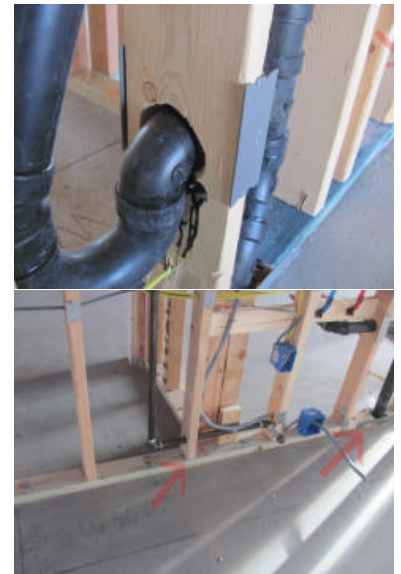
Correction Notice: Interior wall studs were observed to have bored holes larger than the allowed maximum. If a hole is between 40 percent and 60 percent of the stud depth, then the stud should be doubled with no more than 2 successive studs doubled. Holes may not be larger than 60 percent of the stud depth. Bored holes also must be no closer than 5/8 inch to the edge. We recommend that the stud be replaced (or doubled) to meet the requirements. **(R602.6)**

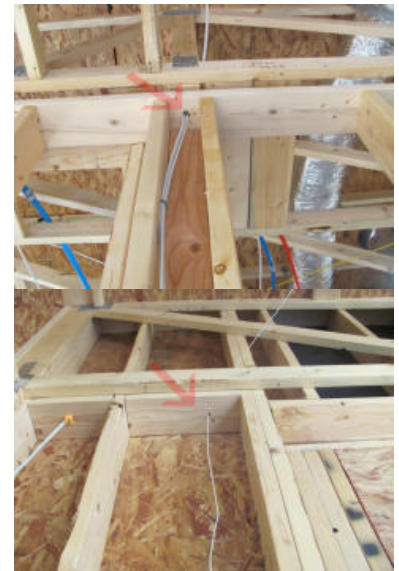
Correction Notice: The required fire blocking was missing or incomplete at the time of inspection (mainly at the alarm wires and one 120v wire penetrations in the master bedroom. We recommend the installation of fire blocking as required. **(R602.8)**

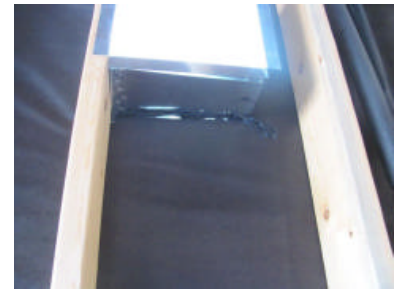
Correction Notice: The moisture barrier was penetrated or had visible holes to the exterior. Holes or penetrations into the interior of the wall create pathways for moisture to enter the enclosed space, therefore, all penetrations or holes must be sealed at the entry point. We recommend that these areas be caulked or repaired as required. **(R703.2)**

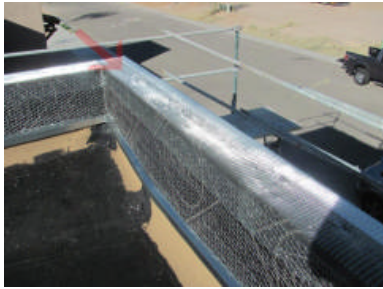
Correction Notice: The nails or staples used at the lath or woven wire were not of an approved type or size for this application (at the rooftop parapet walls). We recommend that the proper fasteners be installed. **(R703.6.1)**

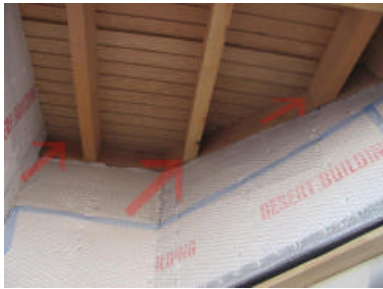
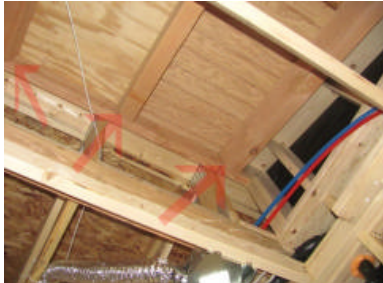
Non Compliance: The rafters above the north walkway and hall bathroom do not have a proper metal hanger at the connection points. We recommend that only the approved hangers specified in the plans be used at these locations.

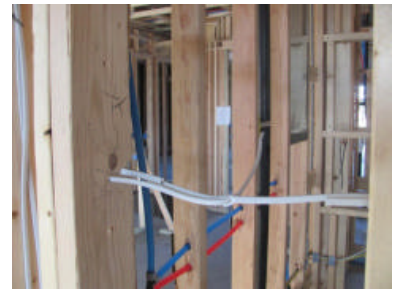
Correction Notice: The master bathroom NM cable was observed without an attachment within 12 inches of the box. We recommend securing the cable as required. (E3702.1)

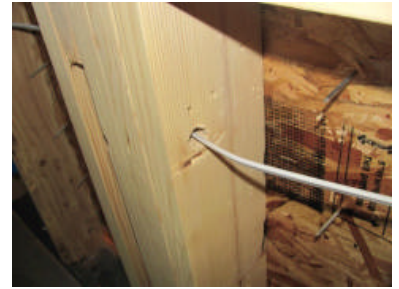
Correction Notice: Protective steel plates must be provided where the 1 1/4" spacing of the bored hole from the edge of the framing stud and 2" of the bottom of a joist or rafter cannot be maintained. We recommend the placement of the proper protective plates or straps as required (missing at the east bedroom). (E3702.1)

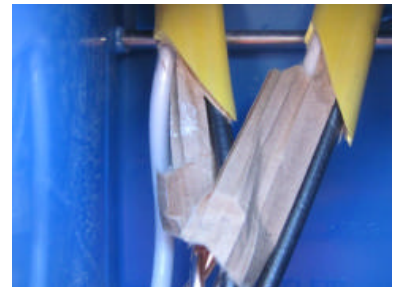
Correction Notice: The wiring sheathing was damaged exposing the neutral conductor at the north wall receptacle. Recommend corrections as necessary.

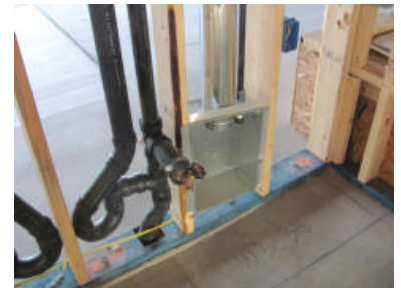
Correction Notice: The dryer vent box is not attached as required.

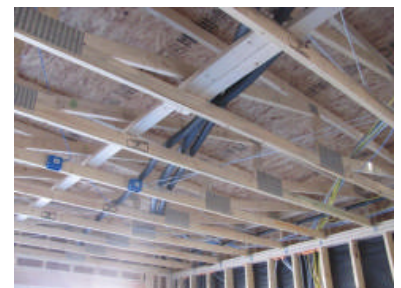
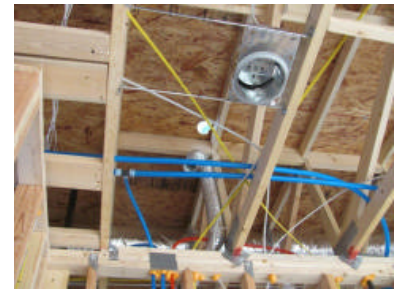
Correction Notice: Piping was observed without the pipe hold down attachments at one or more areas (living and garage). Pex water lines are required to be secured to prevent pipe movement and damage. The maximum allowed horizontal spacing is 48". Replacing all the missing anchors is advised.
(P2603.2.1)

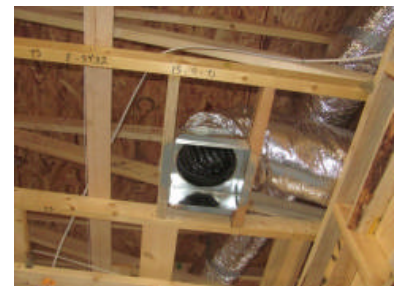
Correction Notice: Registers shall be supported on at least three sides in accordance with the manufacturers installation recommendations. We recommend that the supports at all three sides be installed. **(Manufacturers Installation Guidelines)**

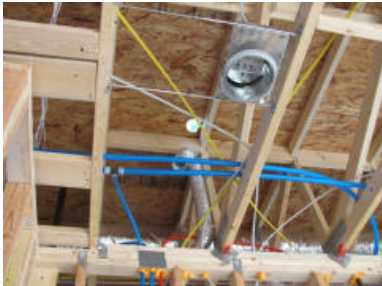
Correction Notice: The bathroom fan exhaust duct at master was not secured by a strap or fastener as required. We recommend that all the bathroom exhaust vents be routed to an exterior location and strapped in place to prevent the duct from movement.
